The recent flooding across Australia has caused loss of life and immense damage to properties. Understanding where to start in the rebuilding or reconstruction process can be difficult. As people now start to assess the damage to their homes, CSR appreciates the situation they may face. In order to assist the process this bulletin will aim to provide relevant information relating to products which may have been affected by the flood waters. Your safety and understanding of what to do is our priority and these recommendations are based on dealing with plasterboard, fibre cement, insulation, bricks, ceilings, hebel panels and roofing products.

## Before the work begins – things to consider...

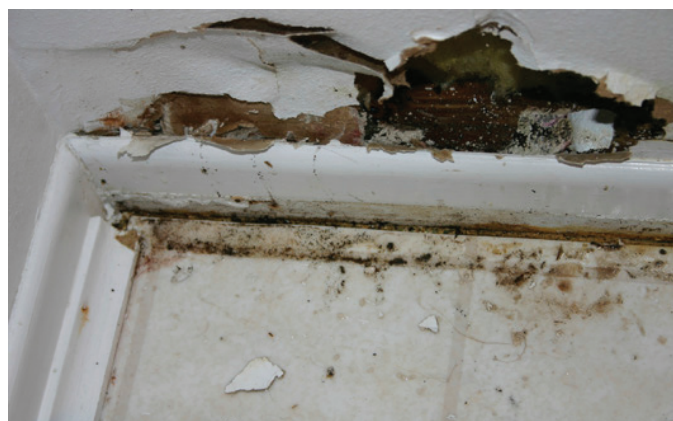
- There is a significantly greater risk to the integrity of plasterboard when it is on ceilings (and ceiling tiles when installed in exposed two way grid), particularly when it is in contact with saturated insulation. Saturated ceilings can be unsafe so it is important to also drain the water carefully. Be alert to warning signs that it may collapse. Starting from the perimeter, away from the worst sagging area, you need to work towards the centre of the sag progressively by poking holes allowing water to exit slowly (or for ceiling tiles progressively removing tiles to allow the water exit slowly). Wet insulation should be removed as soon as possible. In most cases it will not be suitable for reuse - refer below for more guidance.

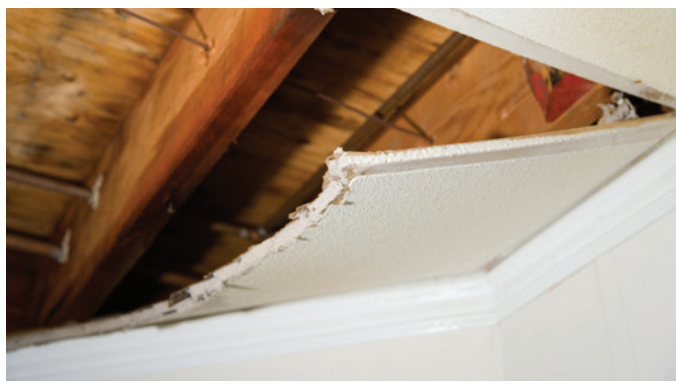
- Almost all ceilings that have been inundated will need to be replaced (especially where absorbent insulation is installed) as excessive water will likely have ponded on the ceiling sheets compromising its integrity as well as its fixings.

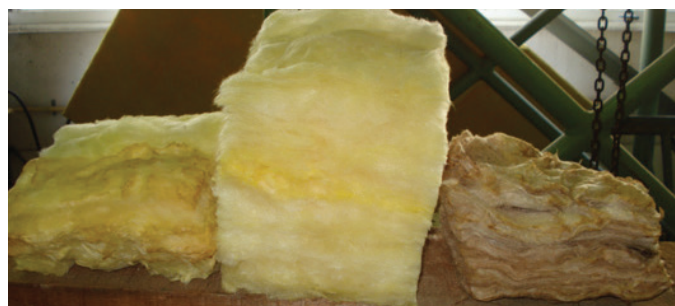
If the insulation has been saturated then it should be replaced - even if insulation is allowed to dry, it is unlikely to recover to its original thickness and its thermal performance will be reduced. Consideration should also be given to the presence of contaminants, which should not be allowed to dry or remain trapped in the insulation.

If the insulation is only slightly damp or partially wet due to a localised leak, and can be dried out, it could be reused provided it recovers to the same thickness as the surrounding insulation.
